# Manhole Inspection Summary

Manhole # S39EE\_030MH

Insp Date: **3/30/07 1:00 PM**

**Location** Address: **1200 VALLEY ST**

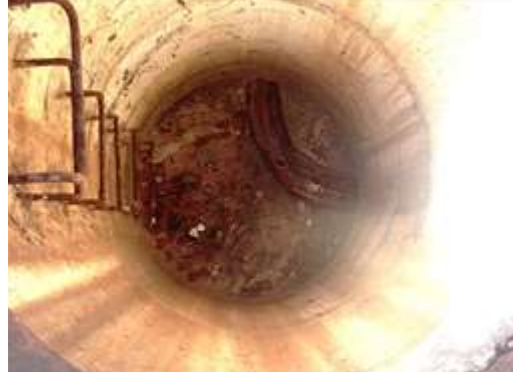
Top View

Barrel infiltration. Evidence of surcharge - Bench debris.

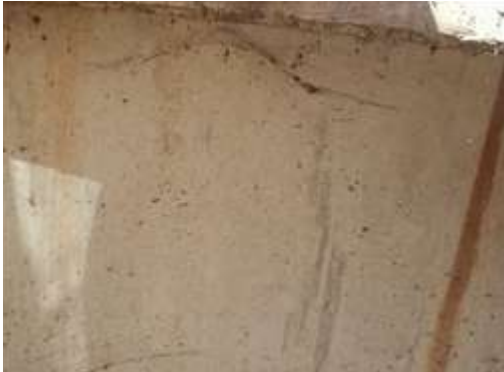
Defect

Corbel infiltration.

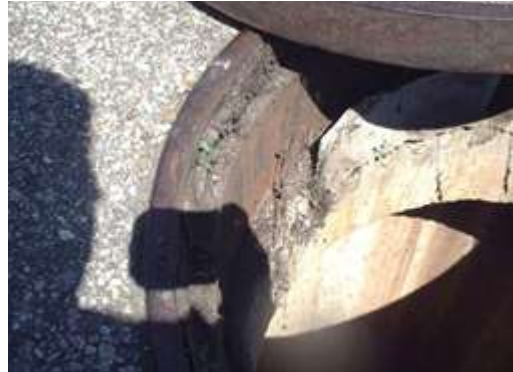
Defect

Frame leaks. Frame offset. Corbel infiltration.

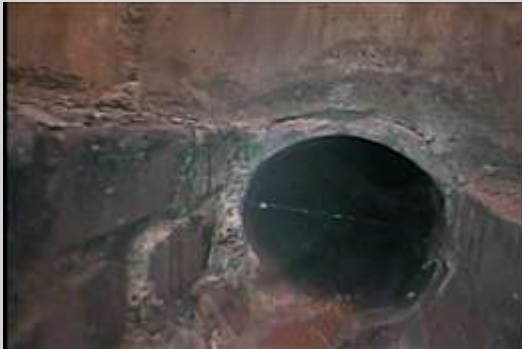
### 8 in. Circular Gravity Sewer Pipe Out @ 12 O'Clock

Infiltration: **None** Pipe Seal Cond: **Broken**

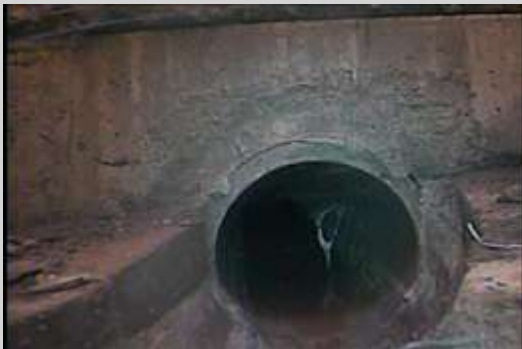
### 8 in. Circular Gravity Sewer Pipe In @ 3 O'Clock

Infiltration: **Evidence** Pipe Seal Cond: **Unknown**
